## Devil's Slide/Hwy 1 Storm Repair

Daily Updates from Bijan Sartipi

**Daily Update**  
July 7

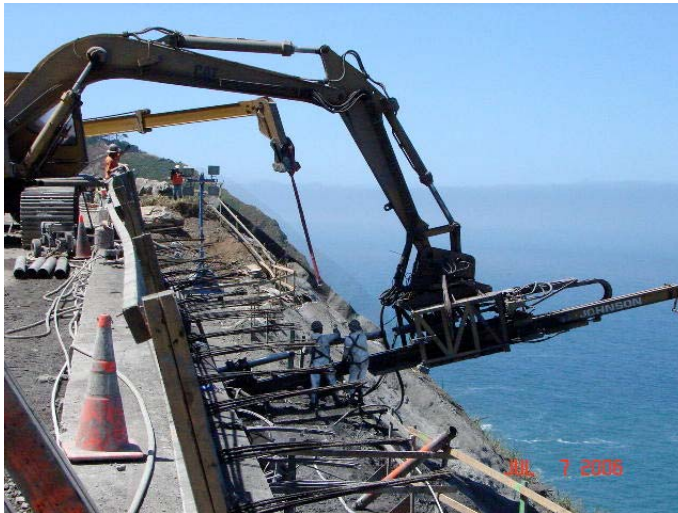
Drilling at level B with reach over rig

- Level 'A' (upper level ocean side) – cables that had been stressed once were checked for tension and re-stressed where necessary.
- Level 'B' (lower level ocean side) – Drilling for tie backs continued using two rigs. 43 of 58 tie backs now installed. Tie back stressing also continued.

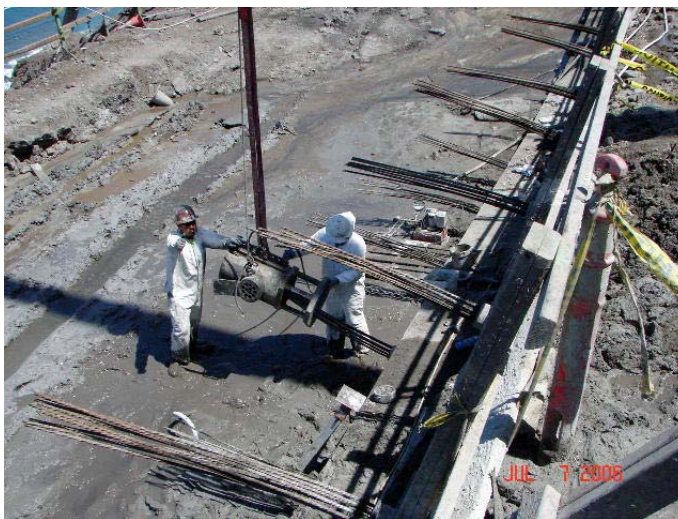
Stressing tie backs – level B

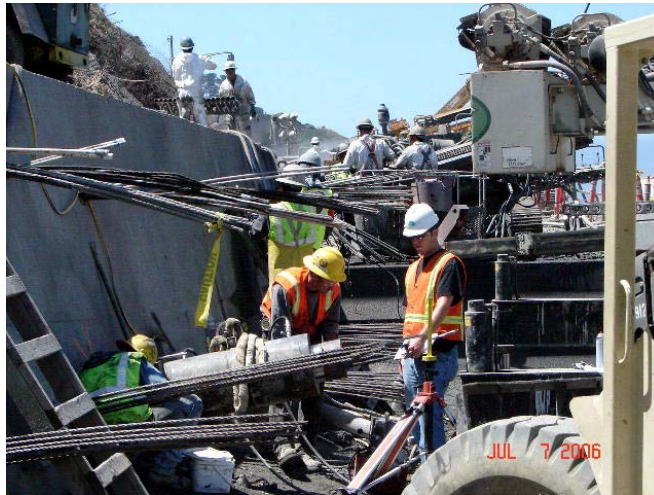
Stressing tie backs – level C

- Level 'C' (lower level cliff side) – Tie back stressing continued.

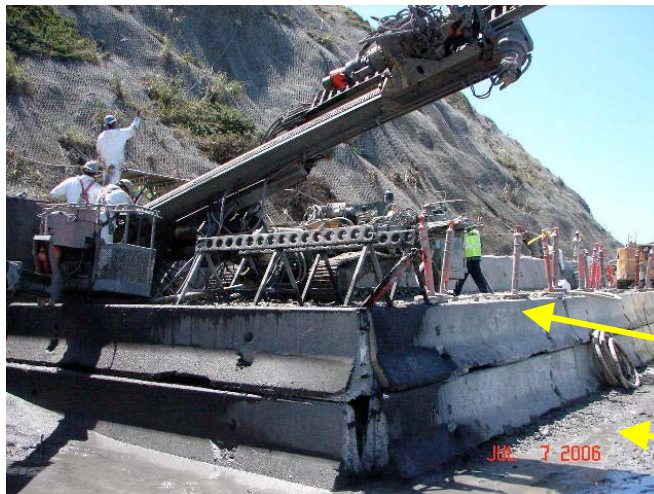
Temporary Bench

Road Level

Drilling at level D – note the temporary bench used to support the drill rig at the required height

- Level 'D' (upper level cliff side) – Drilling for tie backs continued today. 11 of 33 now installed.
